Marc Ellmer, GEA Airflow Services SAS, France, provides a practical guide for identifying and solving air cooled heat exchanger performance problems in the field.

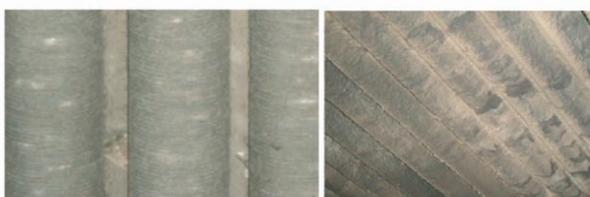
Figure 3. Steps one and two of air side fouling.

In order to properly determine whether a finned tube bundle is fouled externally, a visual inspection should be carried out at the bottom rows of the finned tube bundle. Please keep in mind that bundle fouls from the bottom only and should therefore also be inspected from the bottom using a torch. The dirt will start on the second row and will gradually 'grow' up to the first row clogging the bundle (Figure 3).

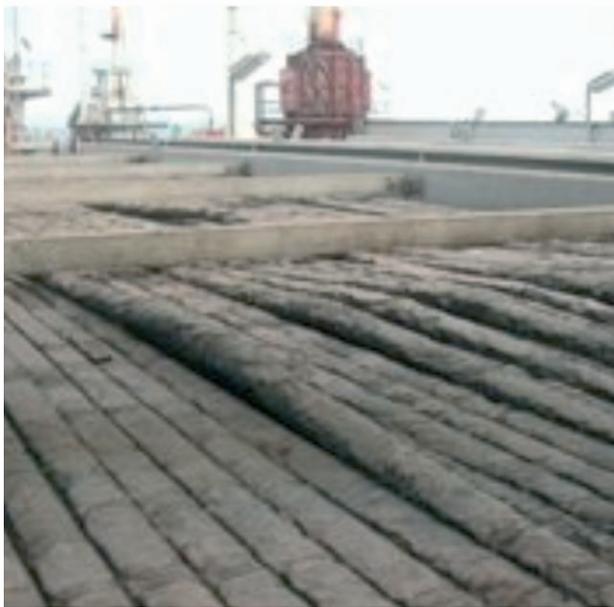
Figure 6. Bent/warped tubes in African refinery.

- Measure pressure drop across bundle and compare to design.
- Inspect for bent/warped tubes (Figure 6), as one plugged tube will be 'colder' than a tube containing hot product resulting in different thermal expansions.
- Use of infrared camera for bundle overview (Figure 7).
- Measuring outlet process temperatures of nozzles using infrared thermometer and non reflective paint (also for points of reference). If there are large differences from one bundle to the other (provided amperage is the same on all fans), chances are there are internal fouling problems (Figure 8).

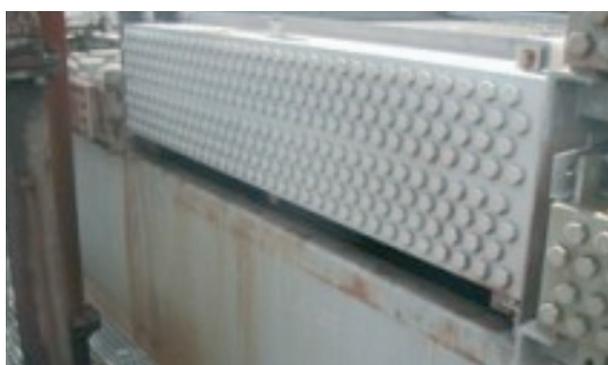
Figure 9. Missing air seals.

Air seals are used to eliminate air leaks that can exist between the bundle and the plenum chamber. They consist of simple pieces of metal that function as seals.

The loss in airflow generated by missing air seals can be considerable. To estimate the loss in airflow caused by missing airflow, the surface opening should be multiplied by 14 m/s, which is the average speed at which the air will go through an opening without any resistance.

Air seals should be inspected for air leaks between the bundles, under the bundle, etc.

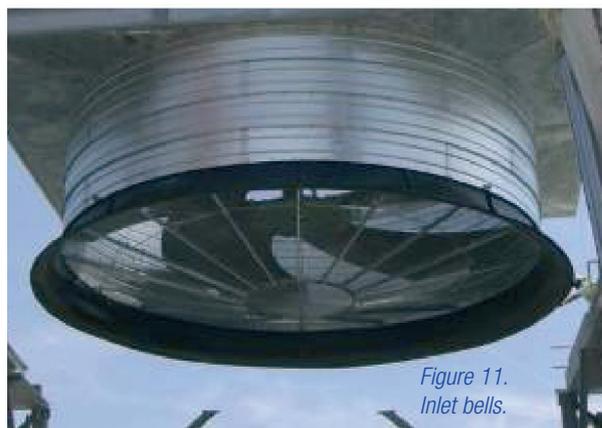
Figure 11. Inlet bells.

- ♦ Inlet bells should be installed at the inlet side to create smoother inlet condition and not to starve the fan at the tip of the blade (vena contracta) (Figure 11).

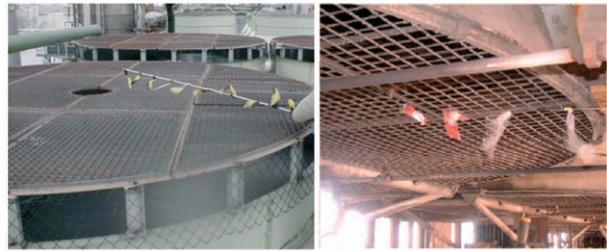
Figure 13. Rod and ribbon indicators.

Using a rod with ribbons indicates whether a fan is running well or not and will pinpoint the problems (Figure 13). When a fan is not functioning well (poor selection, cavitation/stalling of fans, etc.) it is very common to have recirculation at the tip of the blade for forced draft units and at the centre of the fan for induced draft units. A rod with ribbons will tell if a fan has recirculation problems.

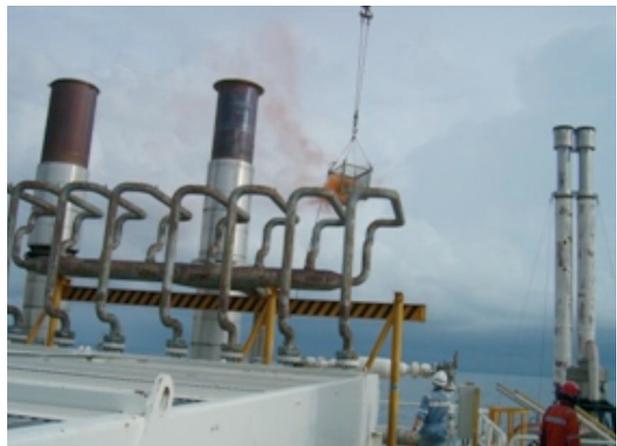
Figure 15. Smoke test bomb on offshore rig.

Hot air recirculation occurs when some of the warm exhaust air from a cooler is drawn back into the intake side or it is (through wind) drawn back into the intake side of another air cooler. Smoke bomb can be a solution (Figure 15). When designing a plant, it is useful to have a CFD modelling in order to detect possible hot air recirculation problems.
